## ABBREVIATED TEST REPORT

**Specimens:** Three (3) set of 5' X 6'4" walk thru frame with slide lock scaffold components

## **APPENDIX A: Photographic Documentation of Test**

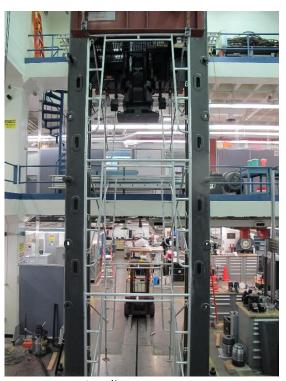
Loading test setup

**Test Method:** The three frames high scaffold assembly with a total height of 19' was erected

with two pairs of cross braces in each frame. The screw jacks inserted to four vertical legs were adjusted to 12 inches beyond the frame length on the bottom. The scaffold assembly was tested in compression in general accordance to ANSI/SSFI SC100-5/05. The load was applied to the four vertical posts via load transfer beams fixed to the cross head of the testing machine at a constant rate of 6000 lb/min to load refusal. The ultimate load and failure

**Test Apparatus:** Southwark-Emery 600,000 lb Universal Testing Machine in 120,000 lb range

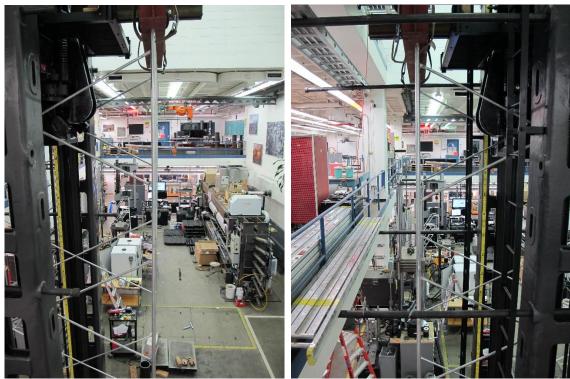
Before test (#1: 5' X 19' scaffold assembly)

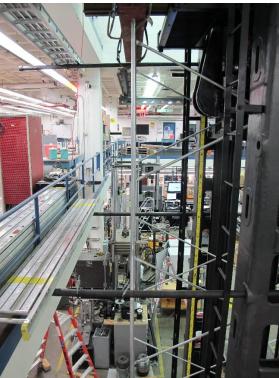
After test (#1: 5' X 19' scaffold assembly)

Specimen No.	Length	Ultimate Load (lb)	Ultimate Load per post (lb)	Remark and Failure Mode Description
#1 (5' X 19')	8′	42,900	10,725	Four posts buckled, cross braces and screw jacks intact
